Construction in Seismic Regions: A Safety Issue Uncovered

Case Study 1 – Condominiums, San Francisco, California

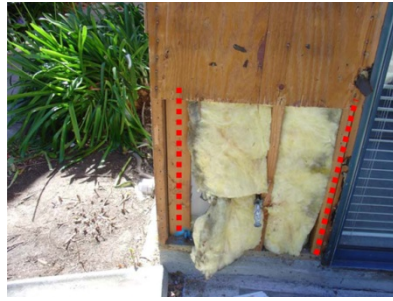
The first case study is a group of condominiums in a large development just south of San Francisco, California (*see figure 1*). The buildings were undergoing a series of improvements which included new windows, siding, and roofing. During the course of removal of the existing exterior finishes, it was noted that many seismic hold-downs were not installed in critical areas as highlighted in red in *figure 2*.

Figure 2: Missing hold-downs (red dotted lines indicate intended locations)

To address the problem, ABB engineered a repair consisting of a strap nailed to the walls of the building and anchored to the foundation via epoxy anchored bolts (*see figures 4a and 4b*). Special care had to be given regarding the bolt locations because the foundation had tension-cable reinforcement (also known as a “post-tension” foundation).

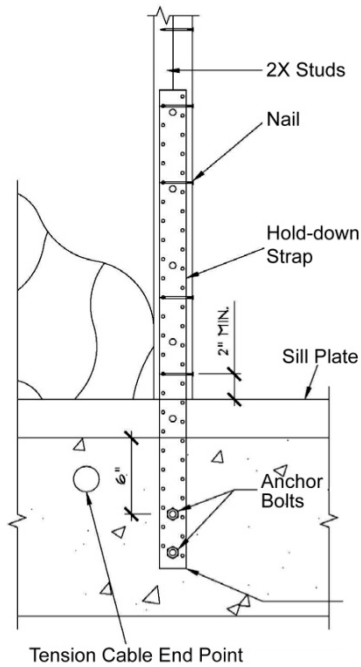
Figure 4a: Hold-down repair detail

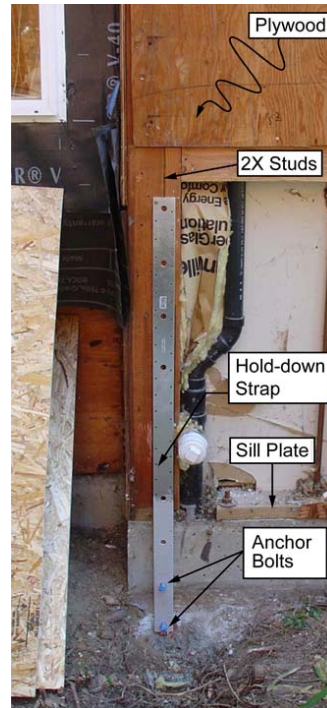
Figure 4b: Hold-down repair installed

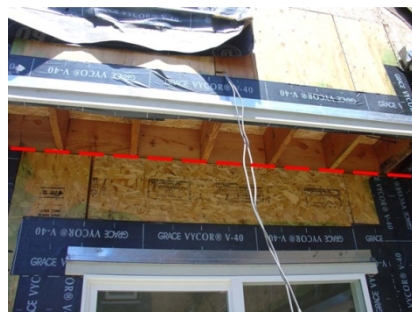
These buildings had additional structural compromises including shear transfer clips not being installed in many locations; specifically the red-lined area illustrated in *figure 5*. Shear transfer clips (*see figure 6*) are steel plates that allow earthquake forces to be transferred from each floor level into the walls at each adjoining level.

Figure 5: The red dashes show where shear transfer clips should have been installed

Simply put, shear transfer clips prevent sliding (*see figure 7*). The repair method involved installing the clips in the appropriate locations as indicated in the red outline in *figure 8*.

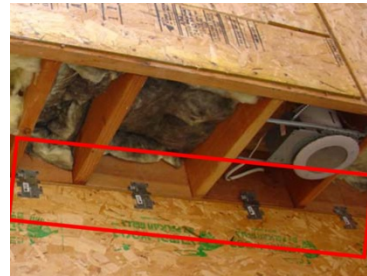
Figure 8: Installation of shear transfer clips

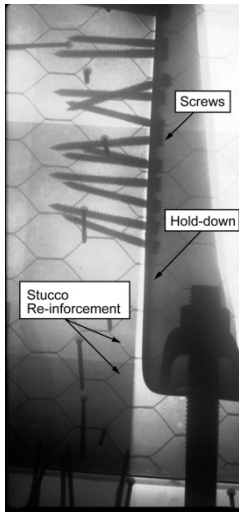
Figure 10: Xray photograph a steel hold-down

In our investigation, the Xrays were taken on site using a small, low power, battery powered Xray tube. An Xray sensitive reusable film was placed behind the object of interest. The region around the machine was cleared of occupants and the Xray tube was energized thus exposing the film to the radiation. The image was then developed on site with a digital scanner and stored on a laptop computer. *Figure 10* shows a resulting Xray depicting a hold-down.

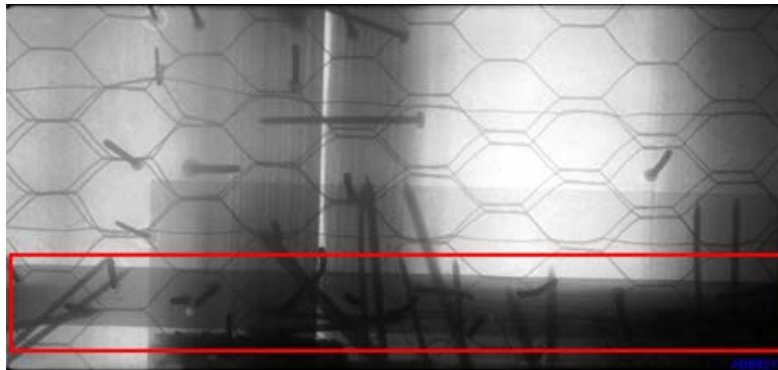
The Xrays depicted the existence and non-existence of seismic straps. *Figure 13a* shows a seismic strap installed; whereas *figure 13b* shows no strap was installed in the intended location.

Figure 13a: Strap installed

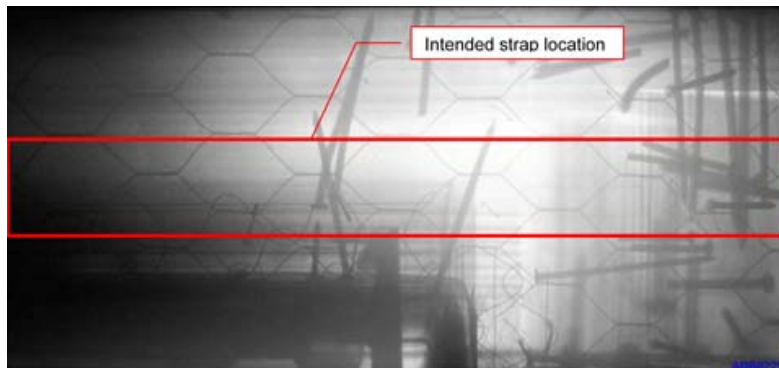
Figure 13b: No strap installed

With regard to the straps and hold-downs mentioned, it was decided in court that each missing component be installed per the original engineer's plans.
