Construction in Seismic Regions: A Safety Issue Uncovered

Case Study 1 – Condominiums, San Francisco, California

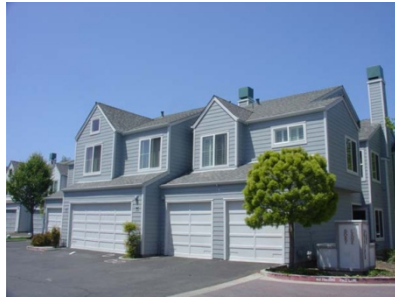
Figure 1: Condominiums, San Francisco, CA

The first case study is a group of condominiums in a large development just south of San Francisco, California (*see figure 1*). The buildings were undergoing a series of improvements which included new windows, siding, and roofing. During the course of removal of the existing exterior finishes, it was noted that many seismic hold-downs were not installed in critical areas as highlighted in red in *figure 2*.

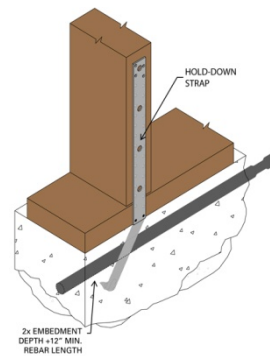
Figure 3b: Typical hold-down which can prevent overturning

Hold-downs are steel ties that prevent the building from overturning during an earthquake (*see figures 3a and 3b*), which is achieved by anchoring the structure to the ground.

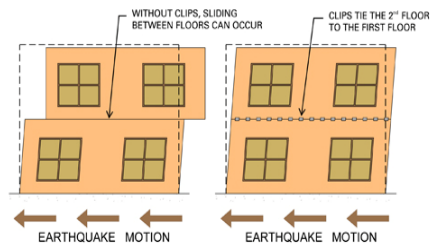
Figure 7: Building with shear transfer clips (left) and without shear transfer clips (right)

Simply put, shear transfer clips prevent sliding (*see figure 7*). The repair method involved installing the clips in the appropriate locations as indicated in the red outline in *figure 8*.

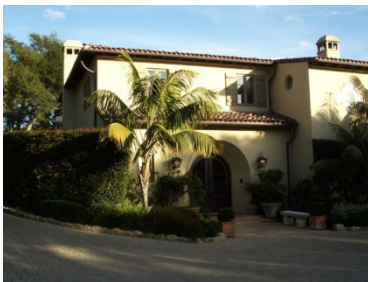
Figure 9: Single-family Residence, Santa Barbara, CA

This Case Study consists of a single-family residence outside of Santa Barbara, California (*see figure 9*).

Various metal seismic restraining components were observed to be missing in the basement of the house. This prompted an extensive review of the building's seismic continuity. However, the owner did not want the interior or exterior finishes to be removed or damaged for the investigation. Because the components under scrutiny were made of steel, ABB decided to use Xray technology to determine the existence of the hardware. Xray locations were randomly chosen by a professional statistician to avoid bias in the assessment.

With regard to the straps and hold-downs mentioned, it was decided in court that each missing component be installed per the original engineer's plans.
